TELEDYNE CONTINENTAL ® AIRCRAFT ENGINE SERVICE BULLETIN

SB95-3B

ALTERNATOR/GENERATOR DRIVE COUPLING

INSPECTION

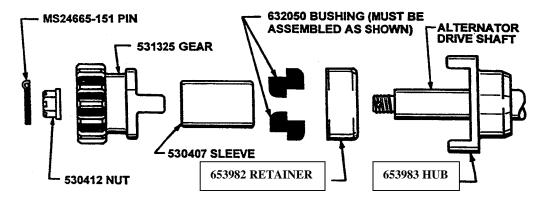
FIGURE 1

PURPOSE: Field reports and inspection of coupling assemblies have revealed parts

- Remove coupling assembly parts 531325 gear, P/N 530407 sleeve, P/N 632050 bushings and 653982 retainer. Do not remove P/N 653983 hub unless replacement is required. Discard bushings and retainer. Inspect nut, gear and sleeve for wear and damage and replace if necessary.

- 6. Install new replacement P/N 653982 retainer and two P/N 632050 bushings into the P/N 653983 hub on the alternator shaft. Bushings must be installed as indicated in Figure 1. Install P/N 530407 sleeve, P/N 531325 gear and P/N 530412 nut.

- 7. Clamp the alternator and hub assembly gear into the protected vise jaws only tight enough the torque the nut. Torque the P/N 530412 nut to 175 inch pounds. Torque may be increased to a maximum of 200 inch pounds to align castellated nut with the cotter pin hole. If alignment cannot be achieved with torque between 175 200 inch pounds, replace nut. Do not over or under torque! Install new P/N MS24665-151 cotter pin and secure in accordance with TCM Service Information Letter SIL93-15 or current revision as applicable.

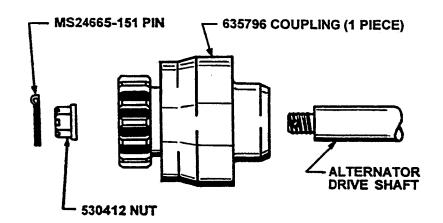
FIGURE 2

The P/N 635796 single piece coupling is designed to slip when abnormal torque is required to rotate the alternator/generator. This can prevent internal engine damage in the event of an alternator/generator seizure. The one piece coupling may be substituted for the coupling assembly shown in Figure 1.

Inspect the one piece coupling for shearing or tearing of the elastomeric (rubber) element. Replace coupling if damage is observed. The following test must be performed at engine overhaul or when slippage is suspected.

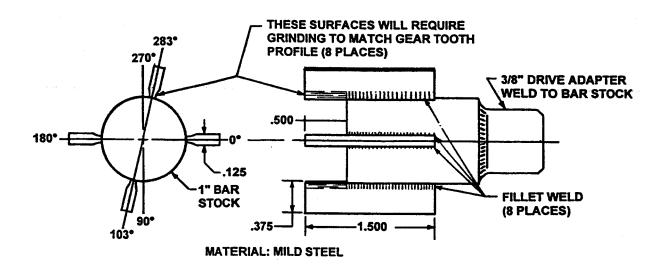
FIGURE 3

- 1. With the coupling removed from the alternator/generator, place the coupling body in the protected jaws of a vise.
- 2. Figure 3 provides necessary dimensions to produce a tool for checking coupling slippage torque.
- 3. Install the tool over the coupling gear and apply 100 inch pounds of torque. No slippage can occur at or below 100 inch pounds of torque. Replace couplings that fail this test.
- 4. Install serviceable or replacement couplings in accordance with section A, paragraphs 7, 8 and 9.
