SERVICE BULLETIN**SB669**

- SUBJECT:** Continental Motors S-20, S-200, and S-1200 Series
Magneto Distributor Gear Block Inspection
- PURPOSE:** Inspect magneto distributor block to determine condition of magneto's distributor gear bushing.
- COMPLIANCE:** During the next 100-hour, progressive, or annual inspection, whichever occurs first and every 100-hour, progressive or annual inspection thereafter not to exceed the applicable time in service requirement.

- AFFECTED:** All aviation gasoline engines utilizing Continental Motors, Inc. (formerly TCM/Bendix) S-20, S-200, and S-1200 Series Magnetos

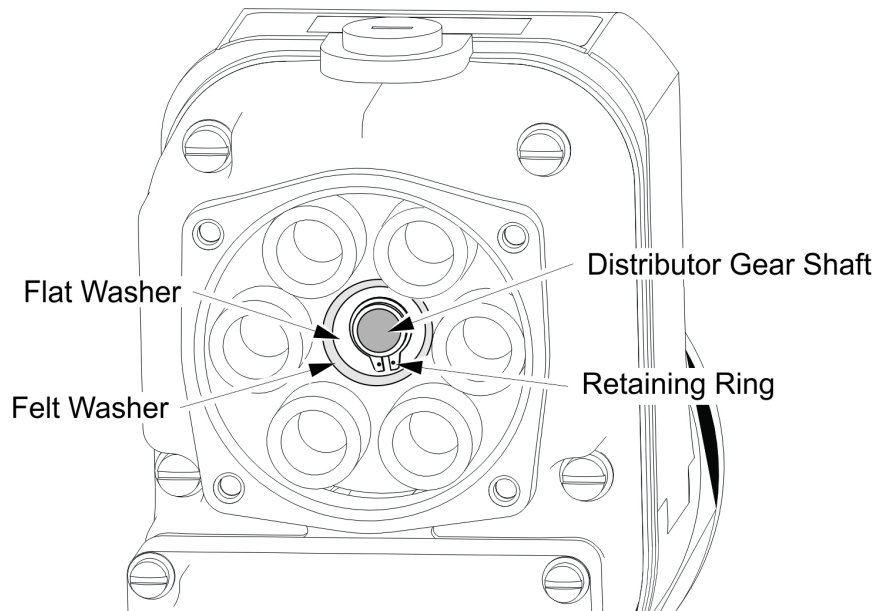
Figure 1. Distributor Block

3. Once the magnetos are accessible, remove the ignition harness plate screws and plate from the magneto distributor housing to expose the end of the distributor gear shaft, the felt washer, flat washer, and shaft retaining ring (see Figure 1).

4. Pinch the distributor gear shaft between the nails of your index finger and thumb and move the shaft radially (side-to-side) to determine if there is any side-play between the distributor gear bushing and the distributor block. If the distributor gear bushing is loose, there should be a consolidated movement noted in the distributor gear shaft, retaining ring, flat washer, and felt washer that is both visible and tactile.

- a. If a loose distributor gear bushing is suspected, remove the magneto and have it replaced (see Warranty Information below).
 - b. If the bushing is secure, apply MS-122AD dry Teflon spray to the harness grommets and seat the harness outlet plate squarely on the magneto.

- c. Tighten the harness outlet plate screws evenly to secure the harness outlet plate to the magneto. Torque the harness outlet plate screws evenly to 12-15 in-lbs.
