MANDATORY SERVICE BULLETIN

DATE: October 18, 2016 Service Bulletin No. 533C
(Supersedes Service Bulletin No. 533B)
Engineering Aspects are
FAA Approved

SUBJECT: Recommended Action for Sudden Engine Stoppage, Propeller/Rotor Strike or Loss of Propeller/Rotor Blade or Tip

MODELS AFFECTED: All Lycoming reciprocating aircraft engines

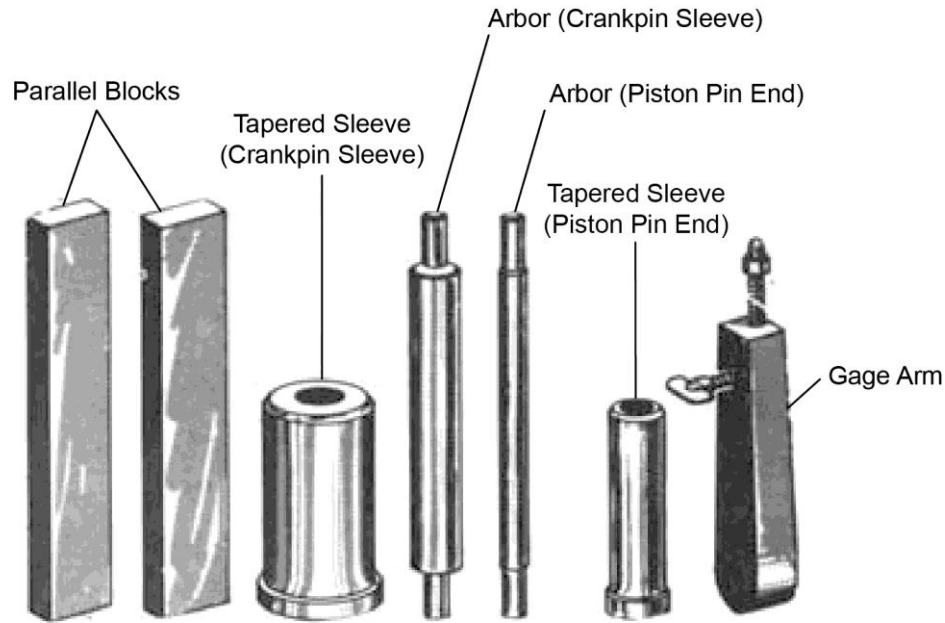
Figure 1
Connecting Rod Parallelism and Squareness Gage

NOTICE: The connecting rod parallelism and squareness gage (Figure 1) is necessary for this check.

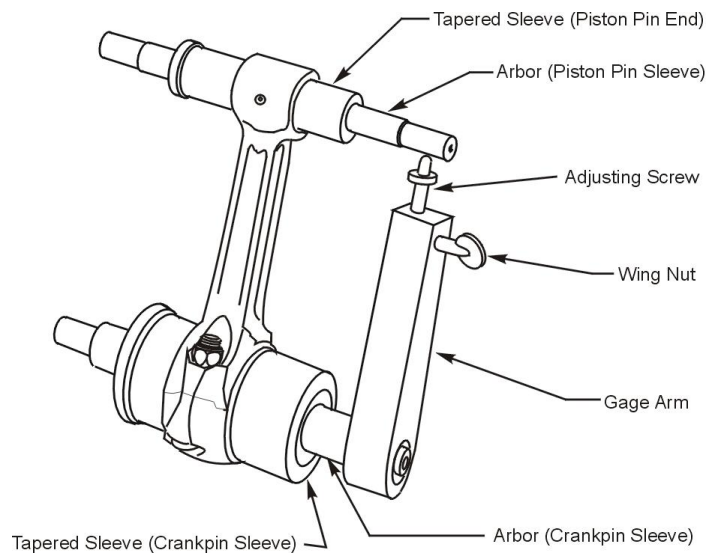
Figure 2
Parallelism Check of Connecting Rods

- A. Verify that the bearing cap is assembled correctly and is tightened securely.
- B. Insert the tapered sleeves (Figure 2) of the Connecting Rod Parallelism and Squareness Gage in the bearing holes in the connecting rod.
- C. Pull arbors through the sleeves.
- D. Put the gage arm on the arbor.
- E. Turn the adjusting screw on the gage arm until it just contacts the arbor.
- F. Lock the adjusting screw with the wing nut.
- G. Make sure the adjusting screw just contacts the arbor.
- H. Remove the gage arm and place it on the other end of the arbor.
- I. Measure the distance between arbors. For exact parallelism or alignment, the distances measured on both sides are to be the same. Record the measurement.
- J. Remove the gage arm (Figure 2).
- K. Keep the sleeves and arbors in place.

18.	Complete a check of connecting rod parallelism.	Refer to the section "Connecting Rod Parallelism/Squareness Check" in this Service Bulletin. Record the parallelism measurement for each connecting rod. Replace all connecting rods not in compliance with measurements in the latest revision of the Service Table of Limits - SSP-1776 (Reference 503).	Parallelism Measurement	
			Connecting Rod 1	
			Connecting Rod 2	
			Connecting Rod 3	
			Connecting Rod 4	
			Connecting Rod 5	
			Connecting Rod 6	
			Connecting Rod 7	
			Connecting Rod 8

Sequential Task	Additional Information	Corrective Action Done/Comments	
19.	Complete a check of connecting rod squareness.	Refer to the section "Connecting Rod Parallelism/Squareness Check" in this Service Bulletin. Record the squareness measurement for each connecting rod. Replace all connecting rods not in compliance with measurements in the latest revision of the Service Table of Limits - SSP-1776 (Reference 504).	Squareness Measurement	
			Connecting Rod 1	
			Connecting Rod 2	
			Connecting Rod 3	
			Connecting Rod 4	
			Connecting Rod 5	
			Connecting Rod 6	
			Connecting Rod 7	
			Connecting Rod 8

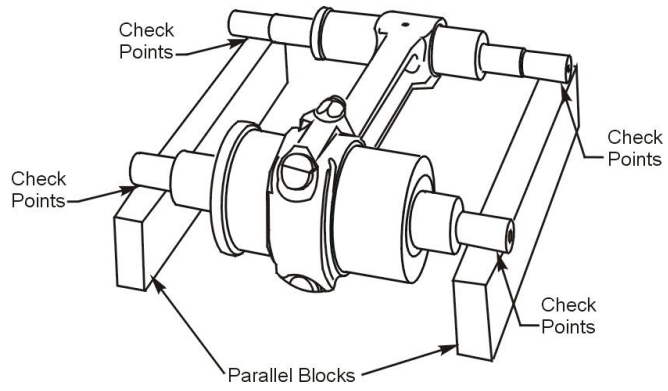
Figure 3
Squareness Check of Connecting Rods

- L. Put the parallel blocks (Figure 3) of the Connecting Rod Parallelism and Squareness Gage on the surface plate.
- M. Put the ends of the arbors on the parallel blocks.
- N. For the squareness or twist check, measure clearance at the four check points in Figure 3 where the arbors rest on the parallel blocks using a feeler gage. Record the measurement.
- O. Compare the clearance between each arbor and the parallel blocks against the values in the latest revision of the Service Table of Limits - SSP-1776. If out of tolerance, replace the connecting rods and examine the crankshaft to make sure the crankshaft is not damaged.
